## Evaluation of Pavement Performance: A Case of Bushenyi-Ishaka Road, Uganda, East Africa

Ahmed Abdirahman Bile, Kolawole Adisa Olonade<sup>\*</sup> and Muhaise Hussein

### Abstract

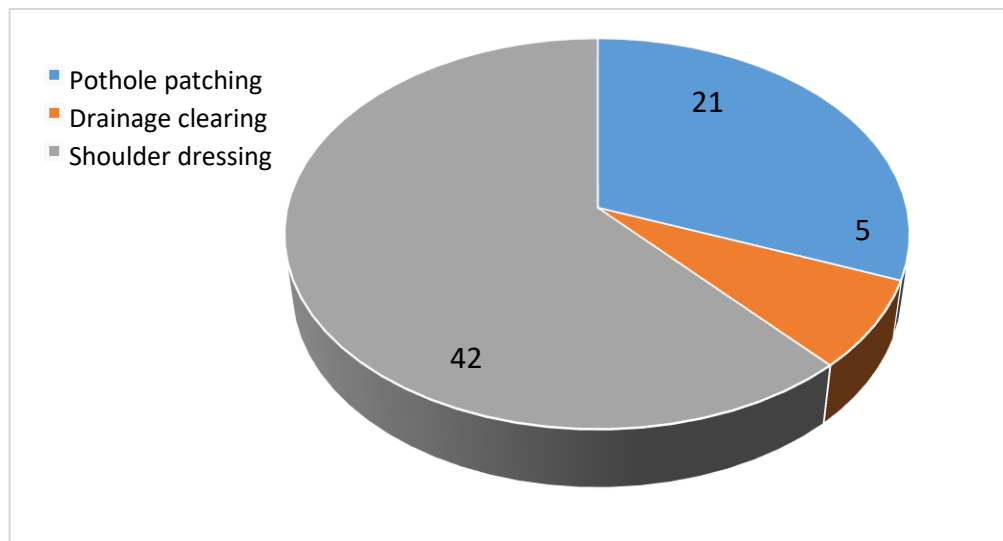
**Figure 3:** Most maintenance strategies that are deployed on the road

From the study, it was established that the most maintenance strategy deployed on the study road is routine followed by corrective and lastly urgent strategies as shown in figure 3. Routine maintenance strategies are always conducted on the study road to keep it at a minimum level of service. According to the

respondents, such routine activities conducted include shoulder clearance, grass cutting and removal of trees that obstruct sight clearance. It was equally gathered that pavement patching formed the major corrective measure undertaken, but there was no record of rehabilitation and surfacing laying maintenance in the last decade.

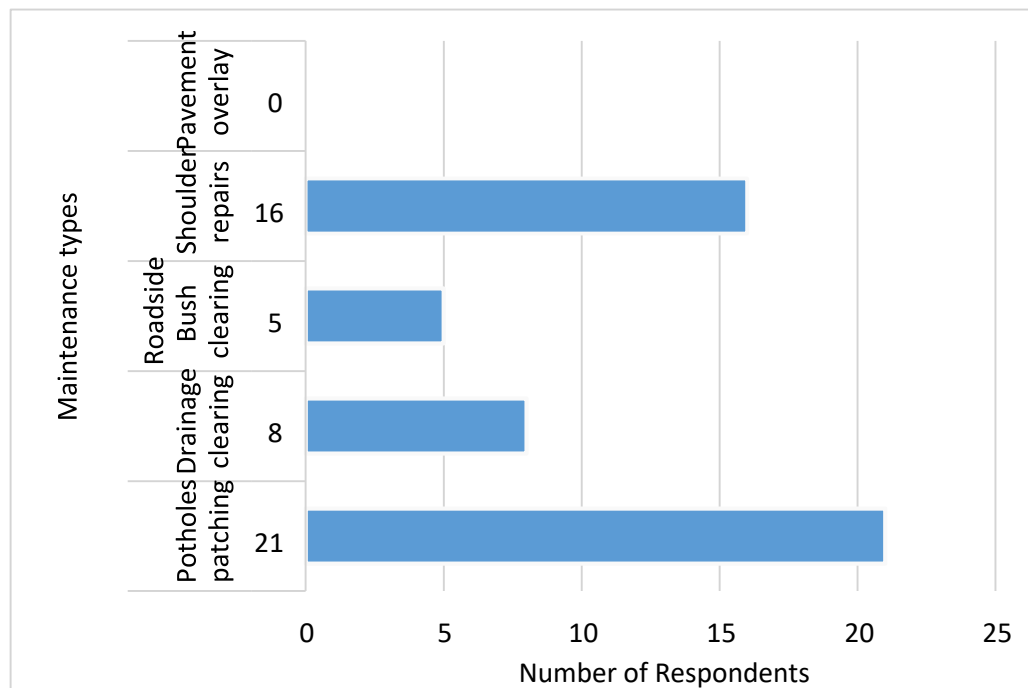
**Figure 4:** Prevalent maintenance types of the road

From the study, most respondents asserted that potholes patching was the leading maintenance

technique deployed followed by shoulder repairs and lastly drainage cleaning and road side bush clearance as shown in Figure 4. Nevertheless, there has not been any major rehabilitation like pavement overlay in the recent past on the road. Without doubt these maintenance activities have positive impact in keeping the road in serving the users. Meanwhile, the performance is still low as established in the pavement performance index computed in the next section of this paper.

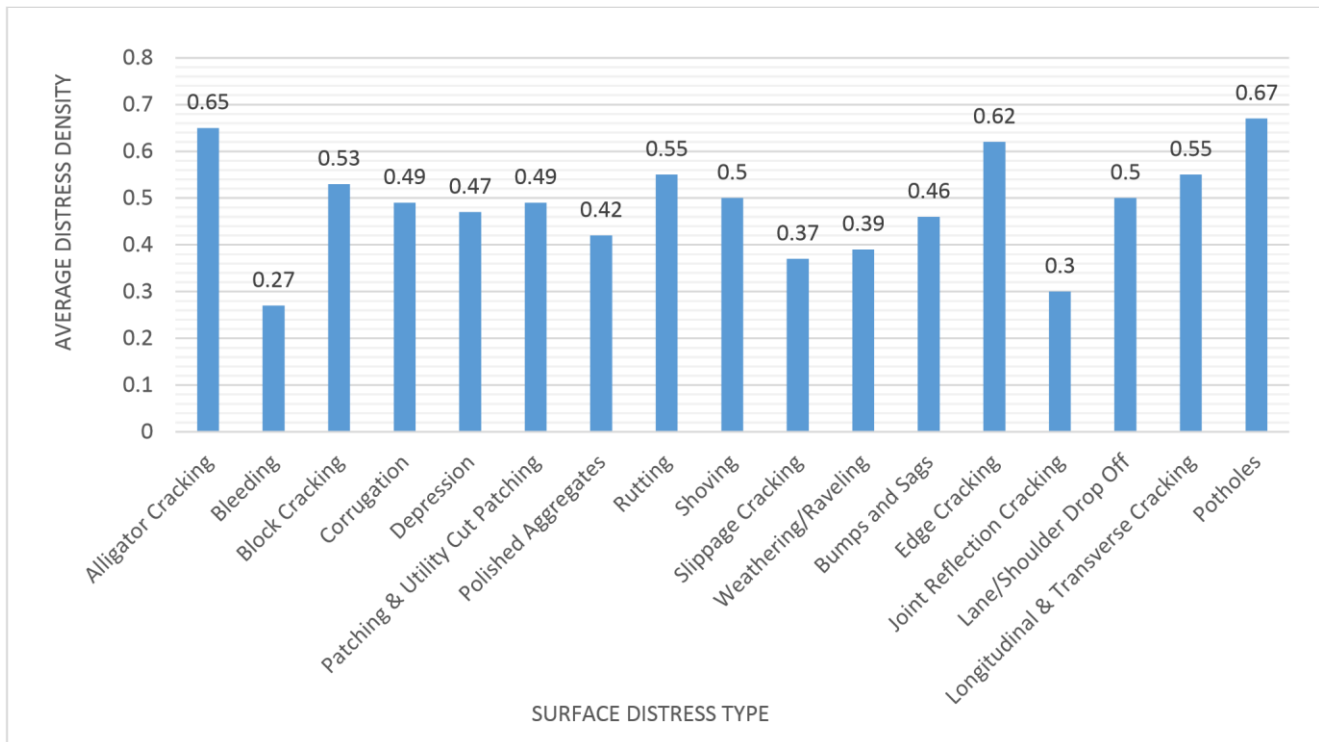
Figure 5: Different Surface Distresses present on the entire pavement and their Densities

Pavement distresses observed on the road were measured and distress density of each defect was determined. Figure 5 shows the different defects observed on the roads as well as their distress densities. The highest distress type on the pavement surface was found to be Potholes with an average distress density of 0.67 (67%) followed by alligator cracking at 0.65 (65%), Edge cracking was 0.62, while Rutting and Transverse & longitudinal cracking at 0.55. Bleeding with a least distress density (0.72) was least distress found on the road. The implication of this is that the road would not perform optimally. For instance, a frequent pothole as indicated by the density means that

the road is rough. Apart from causing discomfort to the motorists, it could also result into severe damages to the vehicles plying the road. As for the alligator cracks, if it is not adequately repaired, it will give room for water to penetrate to the subbase and subsequently to the subgrade. This can degenerate to potholes and complete damage to the whole pavement.

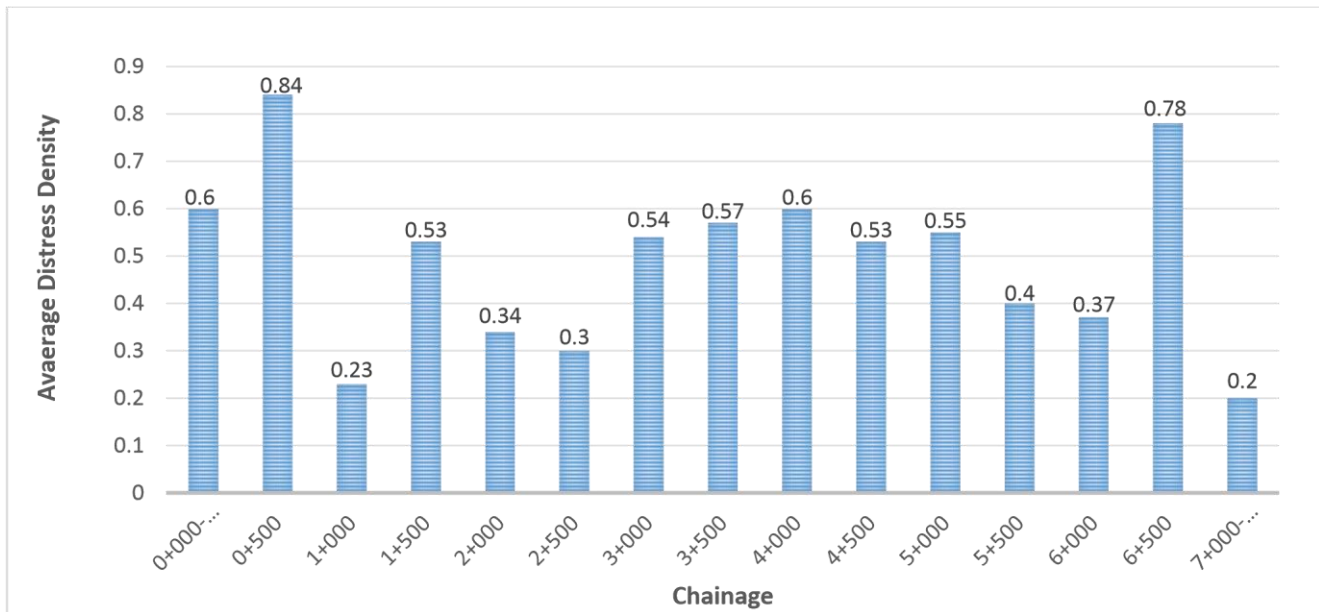
Figure 6: Surface Distresses Densities present at different chainages

Apart from identifying the distresses, the location where these distresses equally identified (Figure 6). This is to facilitate ease of locating where adequate attention is required. As it is seen (Figure 6), Chainage 0+700 (within Ishaka from KIU to the Ishaka town) has

the least form of distresses. Apart from Chainage 0+500 that has highest quantity of distress, there is continuous pockets of pavement distresses from 3+000 to 5+000 (2 km). At this range, it is difficult for motorist to travel beyond about 10km/hr. Any attempt to over speed in this region, will need to accident and severe damages to the vehicle cum serious discomfort to passengers. Therefore, there is urgent need to give the region special attention. The corrective measure here should be complete overlaying of the surface with adequate drainage

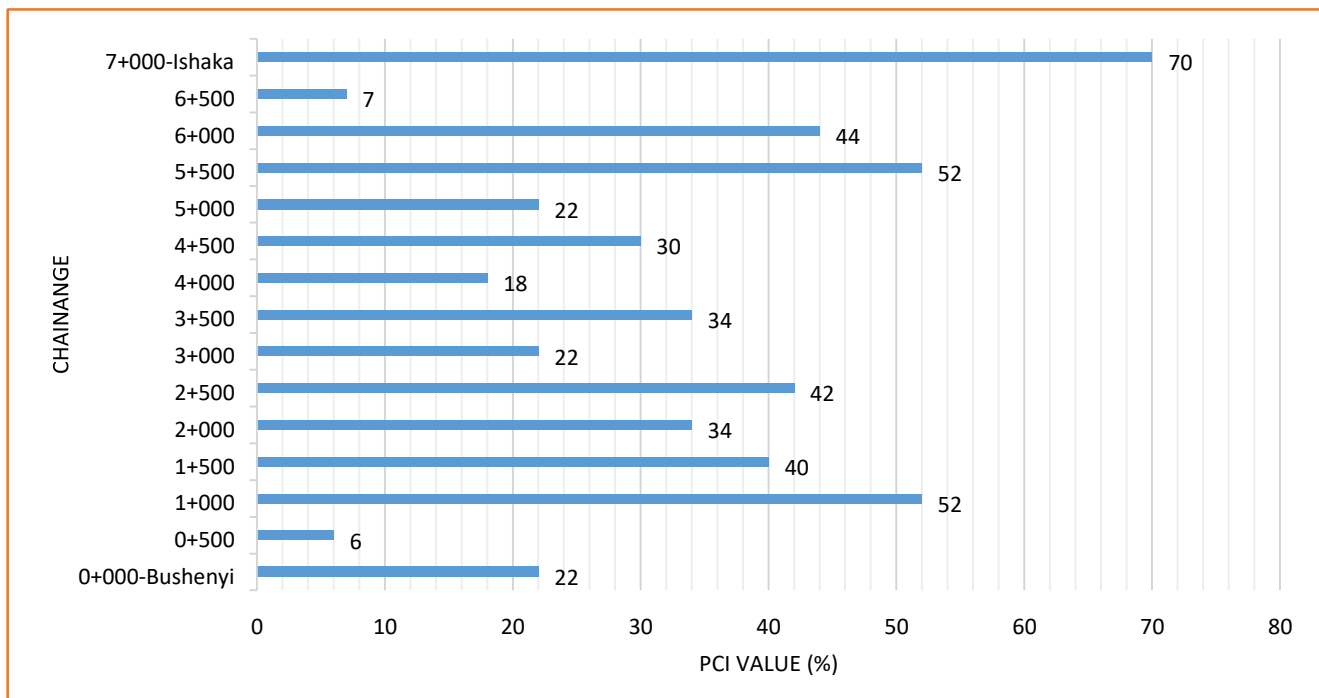
Figure 7: PCI at the different chainages on the road

Pavement Condition Index (PCI) is a numerical means of rating the pavement performance of a road. It provides an insight to the type of maintenance or rehabilitation to deploy to a road depending on the value of PCI. In this study, the PCI values of the road under study was computed first at every chainage of 500m and then average values for the entire roads was determined. The PCI values at designated chainages

are presented in Figure 7, CH 7+000 has the highest value of 70% indicating that it has the best pavement performance compared to others. This is an indication that it has relatively low distresses and more convenient motorists as well as less damaging effect on the vehicle. Generally, the PCI values range between as low as 6% (CH 0+500) and 70% at CH.,7+000.

Based on the classifications of PCI as recommended by (British Columbia Ministry of Transportation, 2020; Denso, 2009), the road portion between CH6+500 and CH7+000 it is adjudged as “Good” because its PCI falls within 60 and 80. The portion of the road in the chainages CH 1+500 and CH 5+000 (PCI < 40) are classified as “Poor” indicating that that portion is not friendly for riding vehicle. Only two portions of the road (CH 1+000 and CH 5+500 to CH

6+000) are accepted to be fair because their PCI values fall in the range of 40 - 60.

Nevertheless, the overall PCI for the entire road is 33% indicating that the road is poor in terms of performance. Based on the overall pavement assessment, pavement maintenance methods are recommended depending on the PCI values. The recommendations are presented in Table 5. It can be seen that current maintenance approach on the road may not salvage the road from imminent collapse.
